**TAX MAP 68
LOT 38
LOT AREA
0.34 Acs±**

New Septic System scope of work:

Proposed Garage Scope of Work: The garage (24'w x 26'd) and house (24' x 36') are small, and the property (0.34 acres) is tiny. We are looking to perform much needed repairs to the garage and gain a little extra space, in 2 ways:

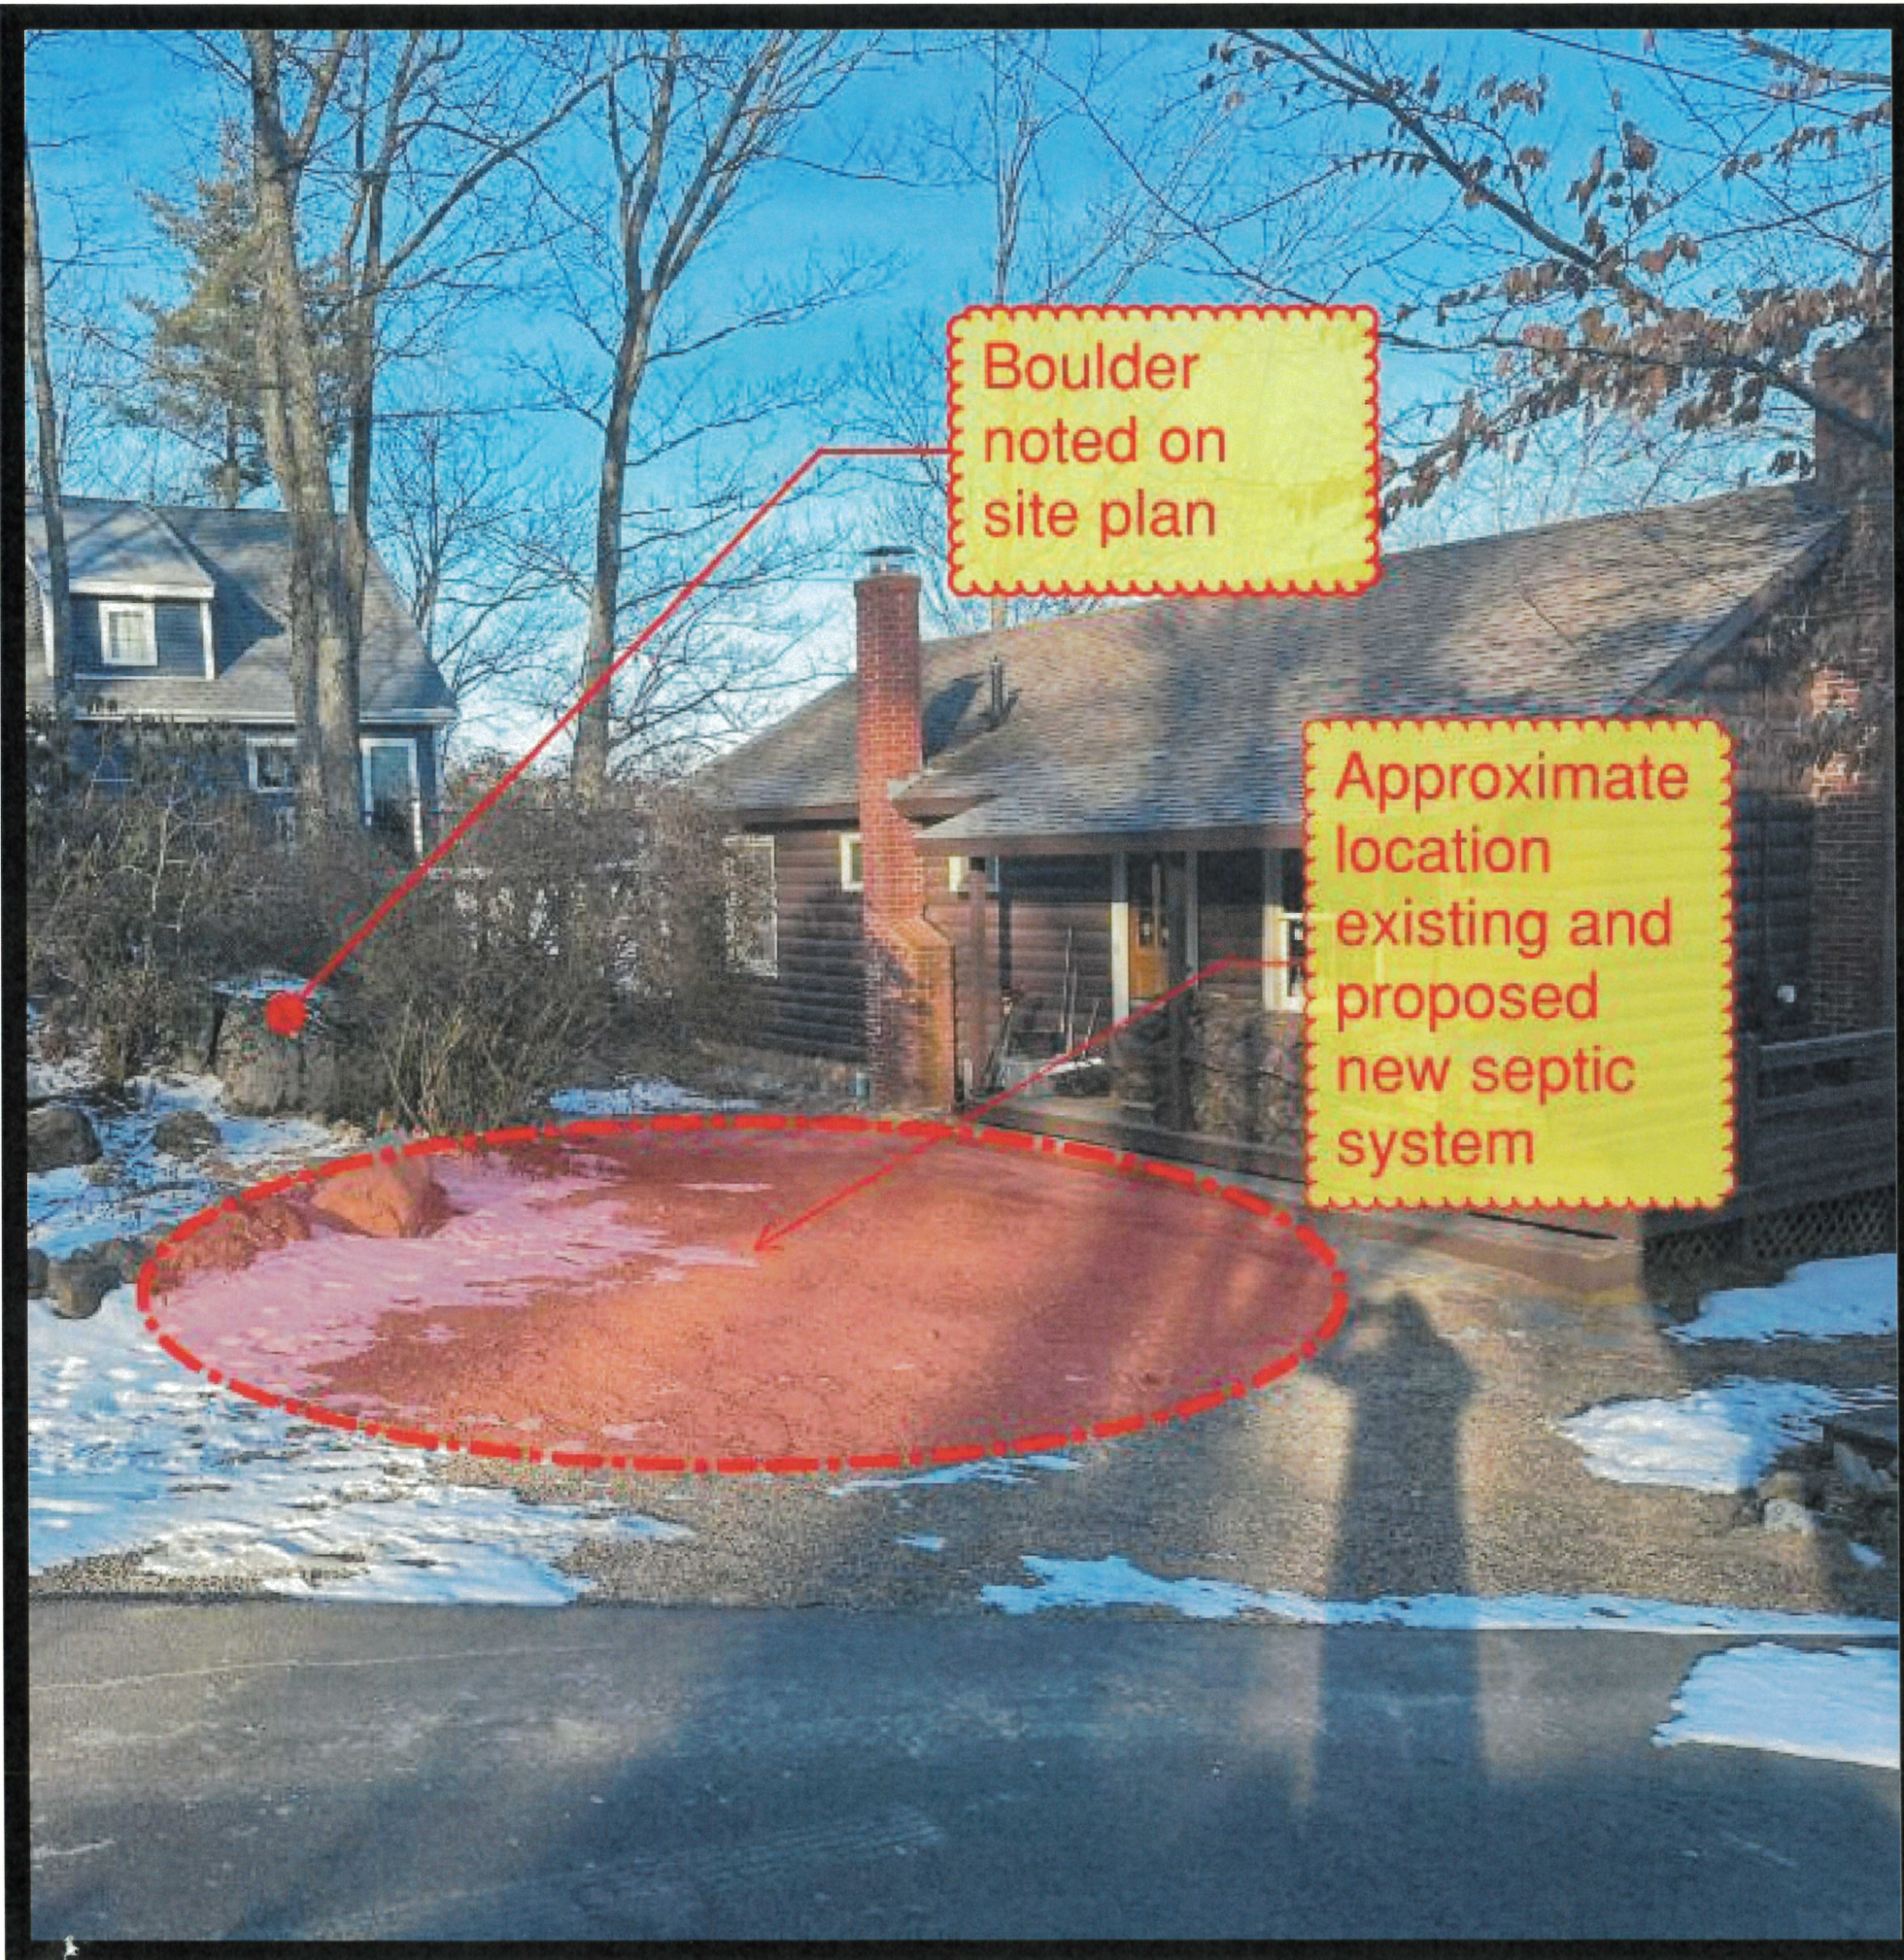
Boulder noted on site plan

Approximate location existing and proposed new septic system

1. Remove existing 1960 +/- era septic system.
2. Install new AOS tank, pump and effluent chambers
3. Adjust grades next to existing boulder.

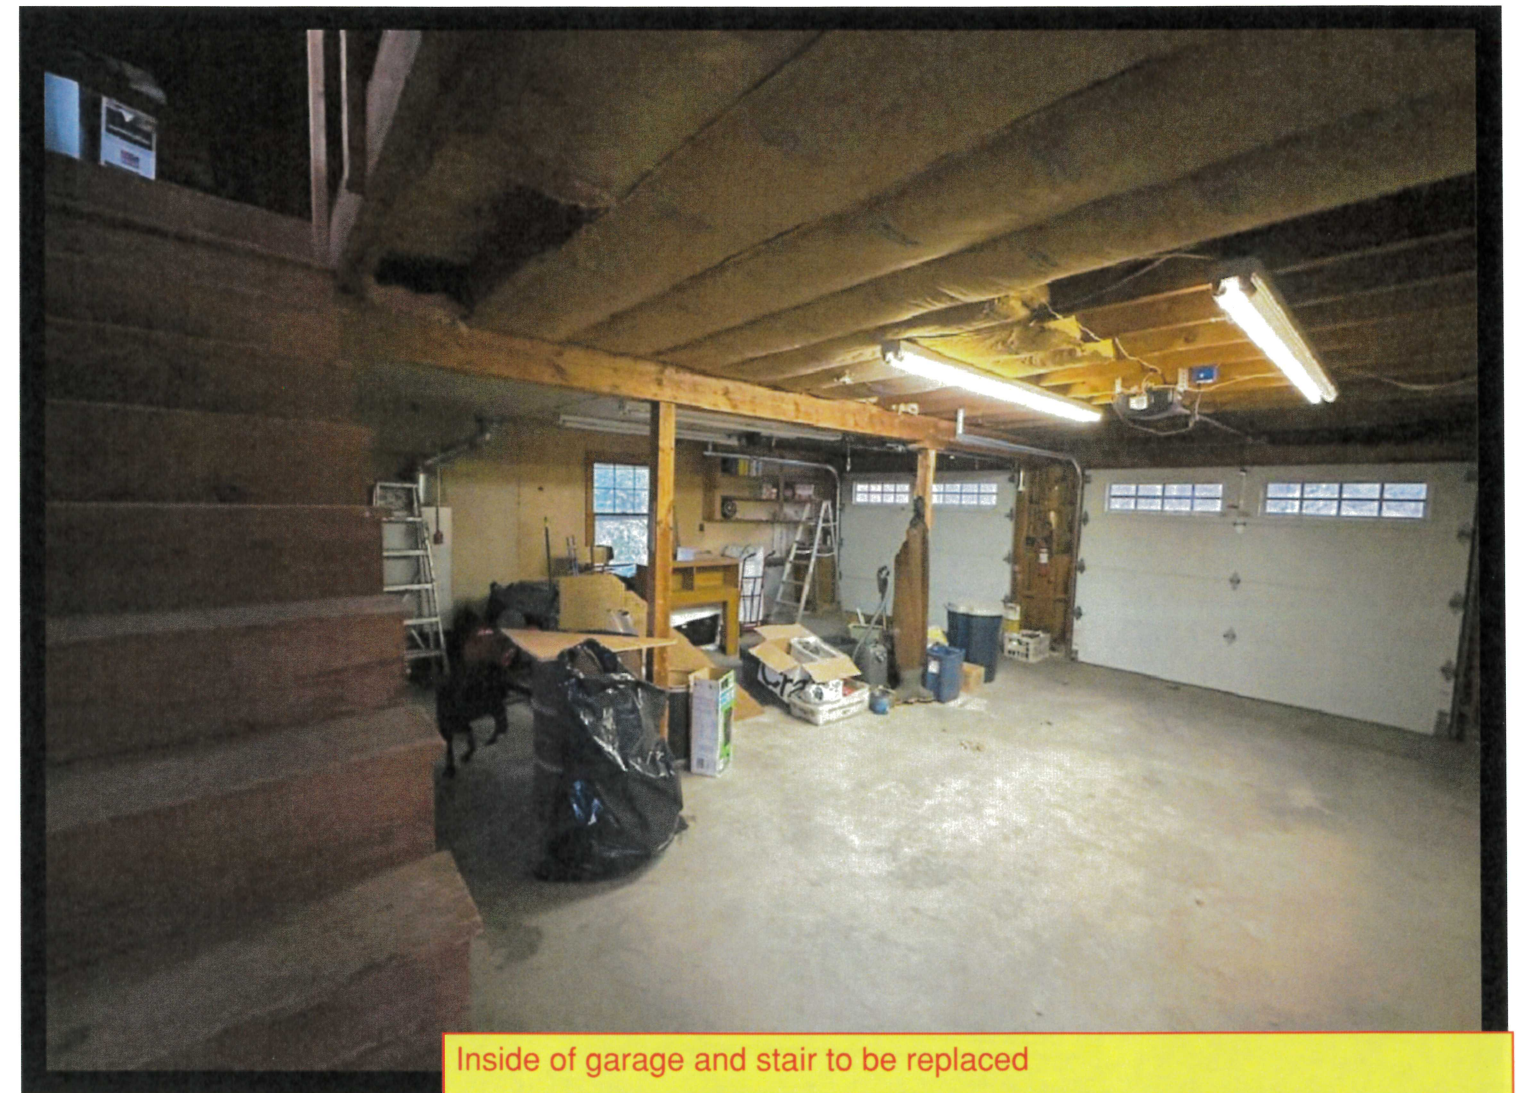
Inside of garage and stair to be replaced

2. Remove the existing interior stair and build a new covered stair outside.

- a). Existing stairs are dangerously steep and not well built.
- b). Moving the stair outside allows for a code compliant stair system.
- c). Recapture space where stair was for storage and a workbench.

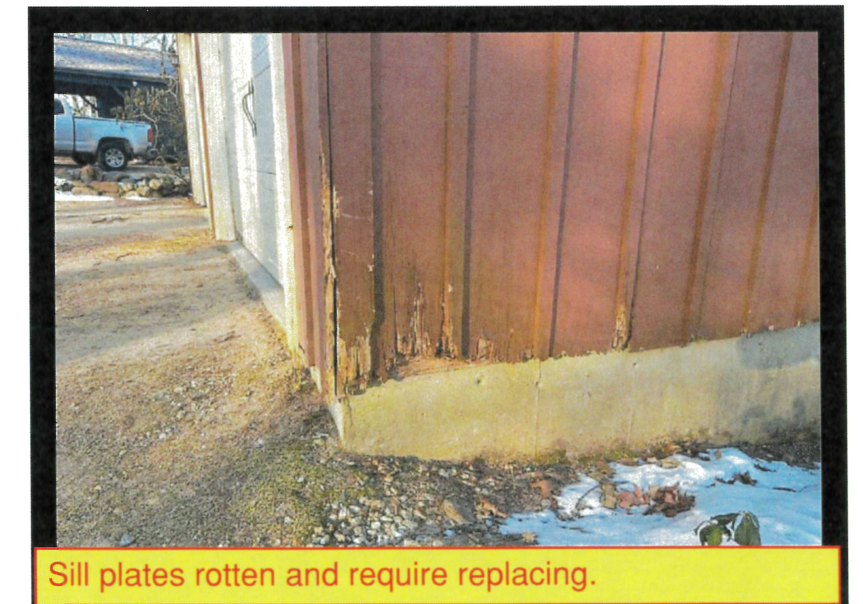
Sill plates rotten and require replacing.

- a). Replace rotted sill plates, siding and windows.
- b). Fix Floor framing damage in install new OH Doors.
- d). The new height would be 31' +/-, less than the 34' maximum allowed (Article II, Section C (6)). This is worst case; the height reduces as you closer to the road.

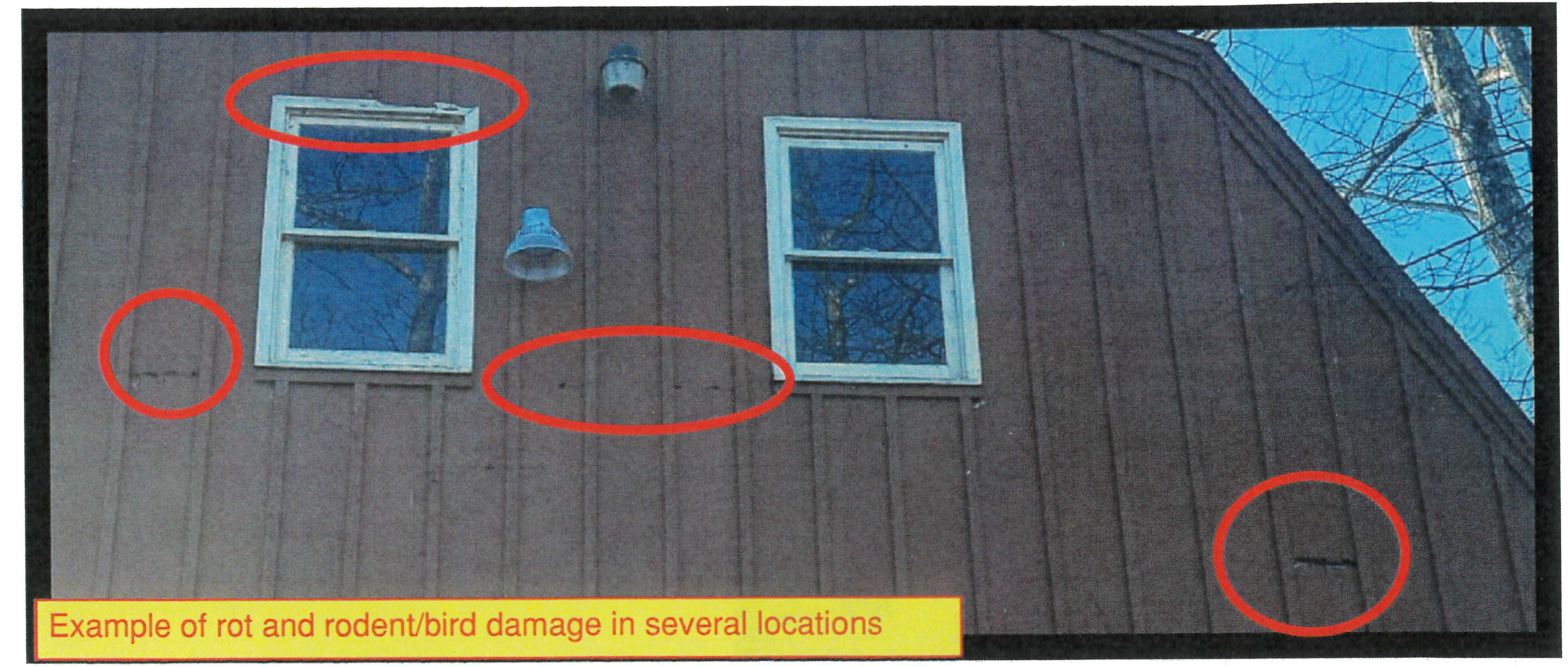
Example of rot and rodent/bird damage in several locations

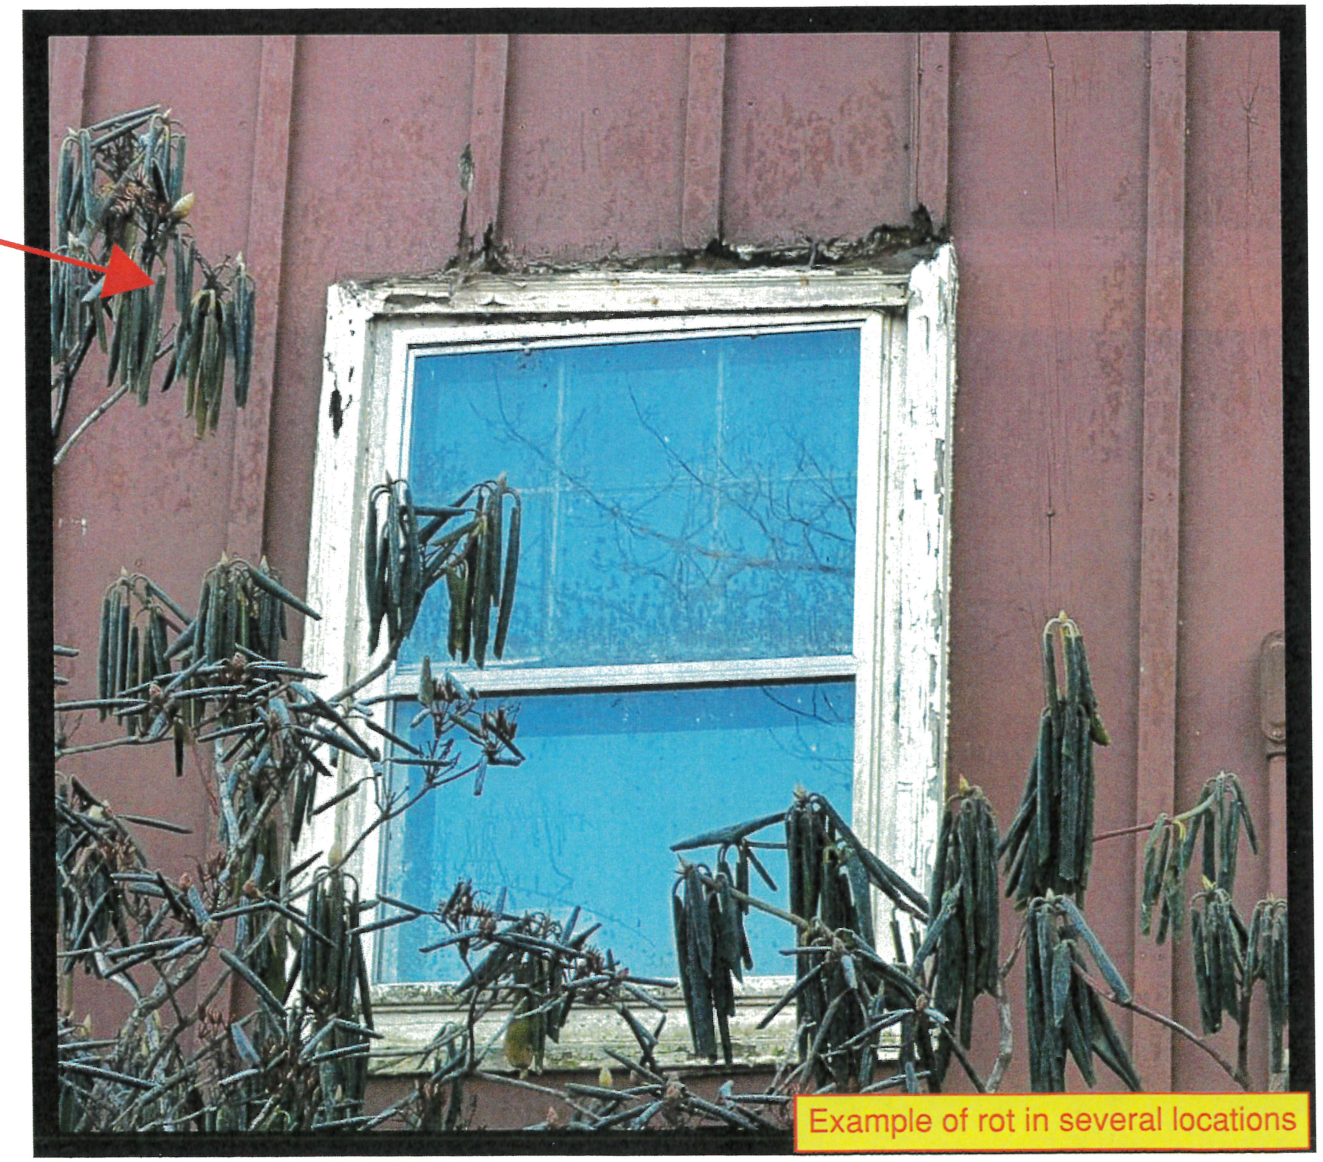
Example of rot in several locations

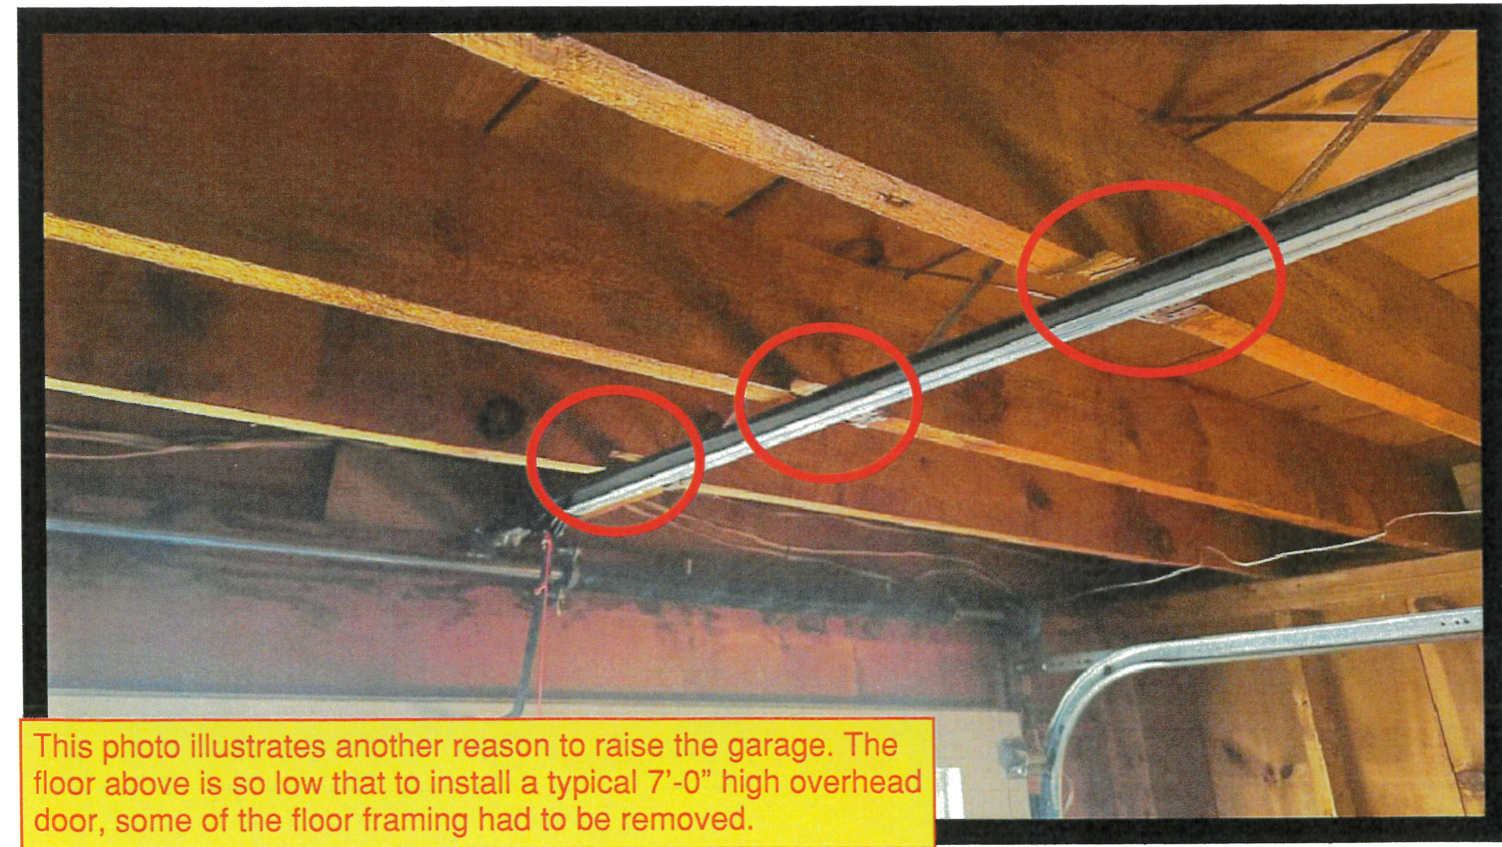
This photo illustrates another reason to raise the garage. The floor above is so low that to install a typical 7'-0" high overhead door, some of the floor framing had to be removed.

1. Raise the structure vertically about 2'-0".
