## **Town Facilities Assessment Committee Report**

The information below is a culmination of meetings and inspections to include both current and future issues. The information contained is preliminary and broad-based and is intended to highlight some short-, mid-, and long-term considerations.

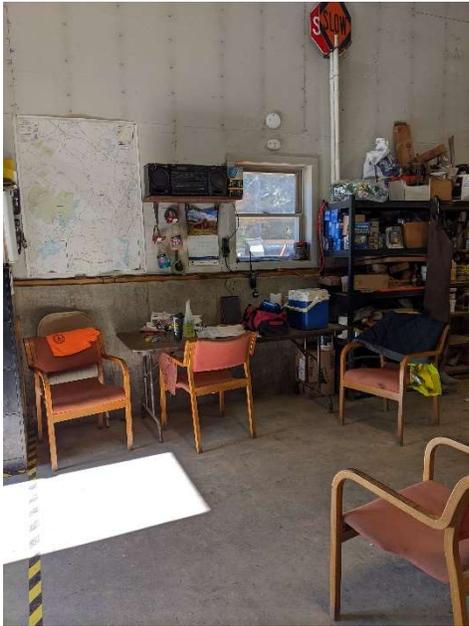
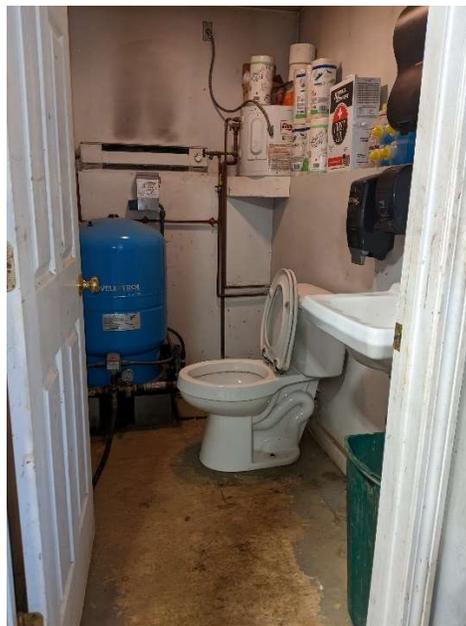
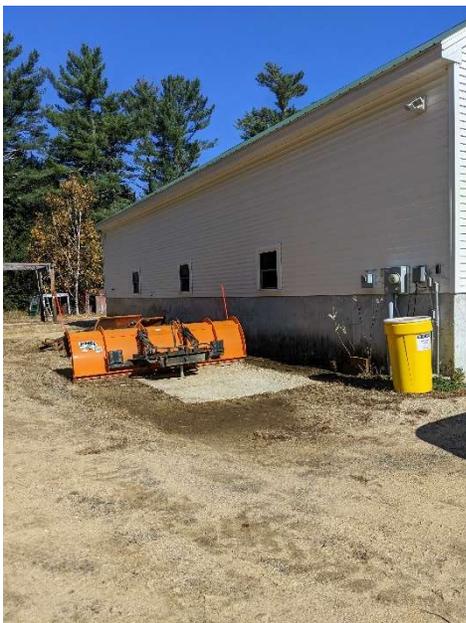
The **highway garage** lacks facility to wash vehicles in winter. An important element in protecting the investment of the equipment due to extensive exposure to salt. It also lacks basic employee support spaces such as office, breakroom, and storage for electronic equipment.

The lot that surrounds the highway garage does not afford the ability to expand in any significant way.

Perhaps a short-term solution would be to provide some employee support space by placing a modest addition on the west side of the building. Size would be determined by function and cost but could be accomplished with minimal impact to current building. Given that plow operators are not usually able to return home between plowing runs, it seems reasonable to consider a modest addition to the left side of the building to house a bathroom, breakroom-meeting space and adequate locker space and storage for sensitive equipment.

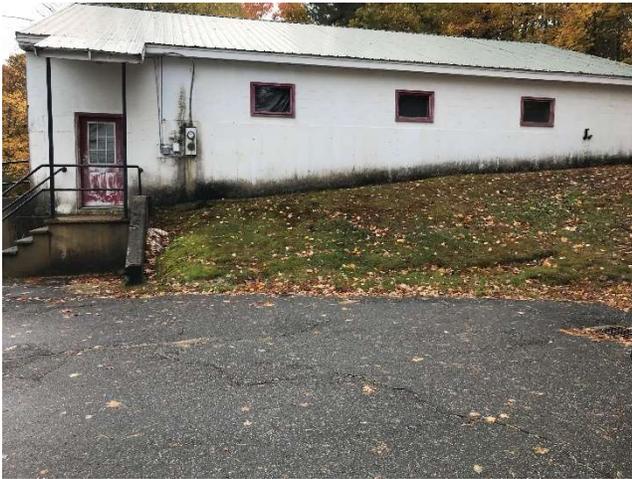
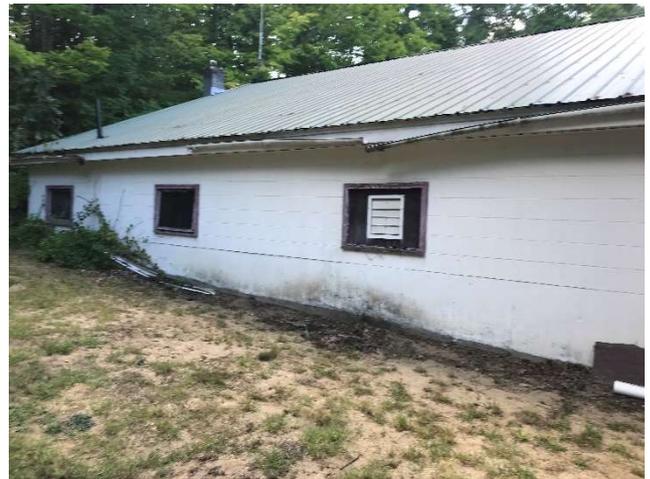
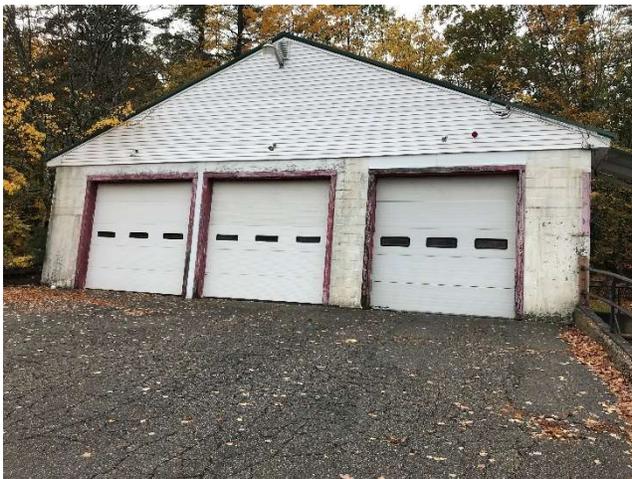
The **old fire station** is used primarily as a storage facility. At this time, there is no other consideration for the use of this building as the steep slope drive is a detriment. It appears the structure is sound and there are no major issues that would prevent the building to function in the current role for many years to come. There is, however, some basic housekeeping that could be done to protect and improve the exterior appearance. Drainage and moisture control need to be addressed. The capacity for storage should only be limited to items that are impervious to moisture, as the lack of ventilation and propensity for mold and mildew is high. This is a town building which is on the main thoroughfare and is visible to all who pass by. Repair trim, paint or vinyl siding, windows, gutters and retaining wall repair should all be considered.

Consideration should be given to petitioning the State to put a pedestrian walkway between the shared Old Firehouse and Old Town Hall parking area and the Library, across Rte152. Perhaps this could be done in concert with an engineering study to determine potential site improvements and/or demolition of the existing structure if storage needs are relocated.

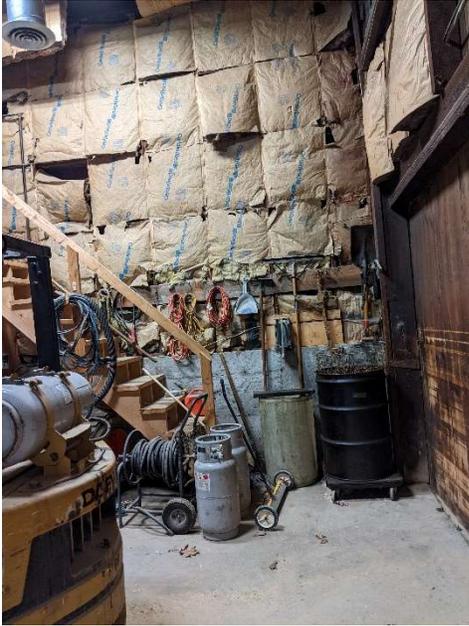
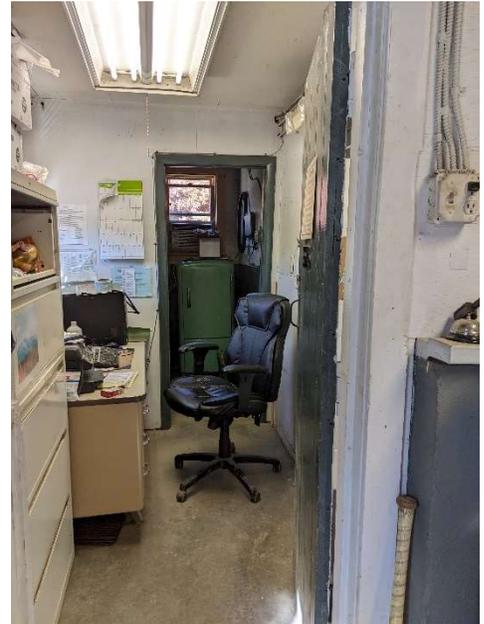
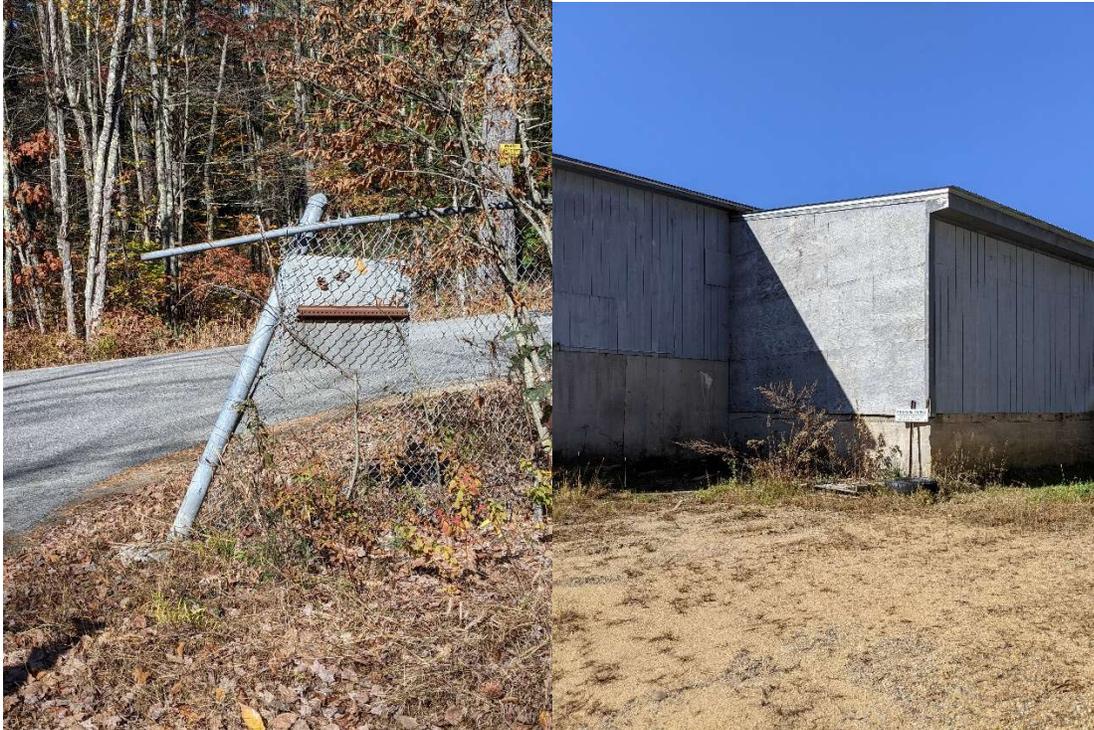
The **recycling center** is currently inadequate for the size of the operation. The limitation is mostly due to space and layout of the building and site. While traffic flow outside is a safety concern, there are not many changes that could be made to the current site to improve the flow of the community traffic and internal operations. Site limitations make expansion or re-routing traffic an improbability. Given only a small percentage of residents use the facility, if that percentage were to increase, there would be a real concern that the facility would be overwhelmed.

There are maintenance and cosmetic issues that persist due to a lack of a dedicated town maintenance resource. There are currently 4 employees to support the recycle center. These employees are currently tasked with recycling center operations and provide housekeeping within the facility. There is no

provision for regular maintenance or upgrades. The recycling center would be well served by a town wide maintenance resource. Perhaps consideration could be given to a small portable which could be placed on site to act as an employee break area and fee collection office, freeing interior space for operational use. A temporary solution until a plan can be formulated to address the more looming question of site viability.

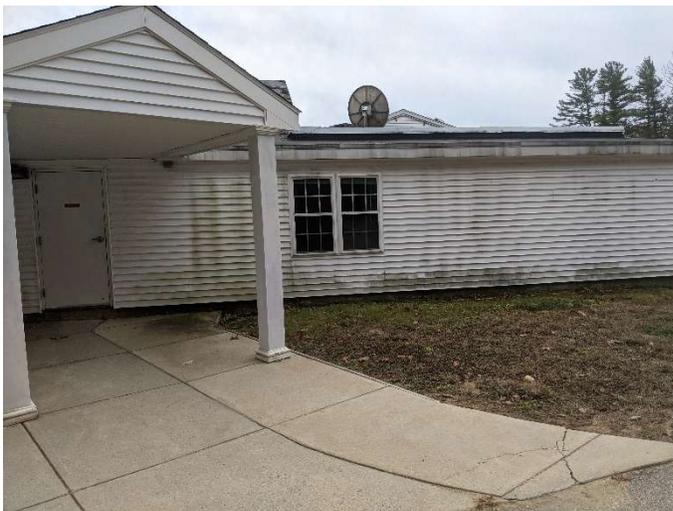
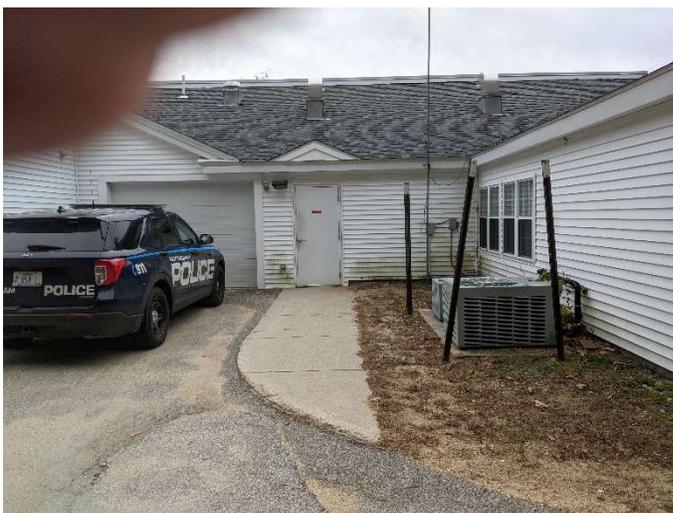
The proximity of the of the department to the rec department and community center activities creates a hazard for officers leaving during an emergency call. There is narrow and difficult access for the patrol

car parking area and entry to the sally port, which could easily be blocked off intentionally, inadvertently, or by weather conditions. Also, being next to the food pantry loading area creates a potential issue and clash with food pantry operations. There is also some reasonable concern that certain “guests” of the department are also too close to the rec department/community center and the youth and elderly population that frequent the facility.

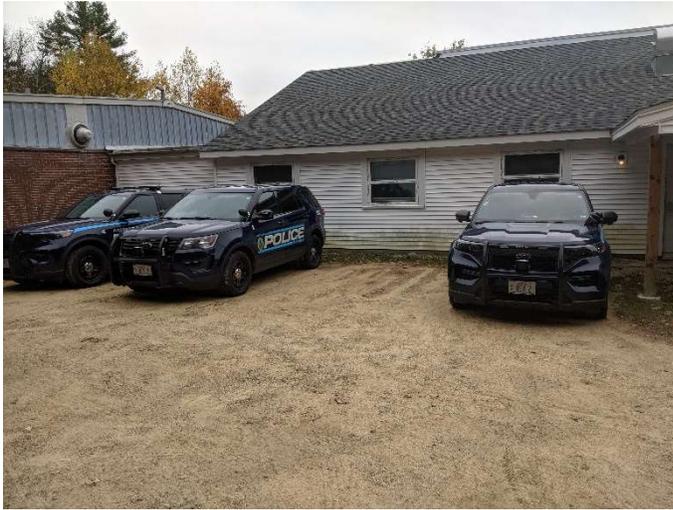
There is also accommodation for only one (often none) police vehicle in the sally port. Exterior storage of vehicles is less than ideal.

The investment of vehicles and all the electronic and ancillary devices which are included is significant and exterior storage compromises the life span and security of each asset.

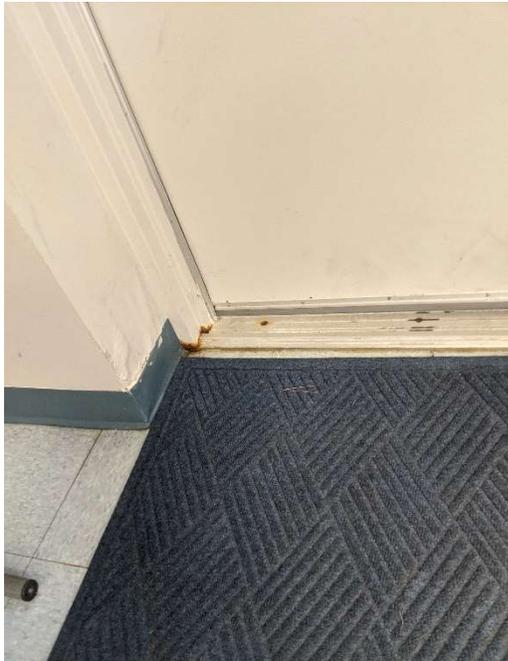
There are roof leaks at solar panels.

There is some corrosion at the entry doors which is caused by splash from the roof and lack of gutters or water diversion, as shown to the left. Some maintenance is required to the doors and some form of gutter should be installed.

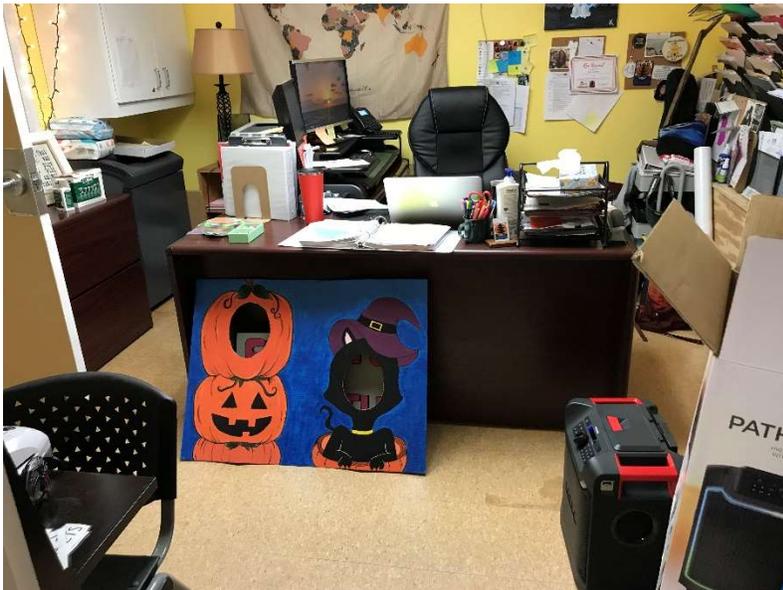
The picture below clearly shows that the office space is woefully undersized and is indicative of the conditions that the operation is subject to.

Kortney has made recommendation that the community room undergo renovation to accommodate some of the space needs that they are experiencing. The room could be outfitted with individual office spaces, storage and activity areas which would add safety and efficiency to the department. *The committee recommends this renovation as a priority.*

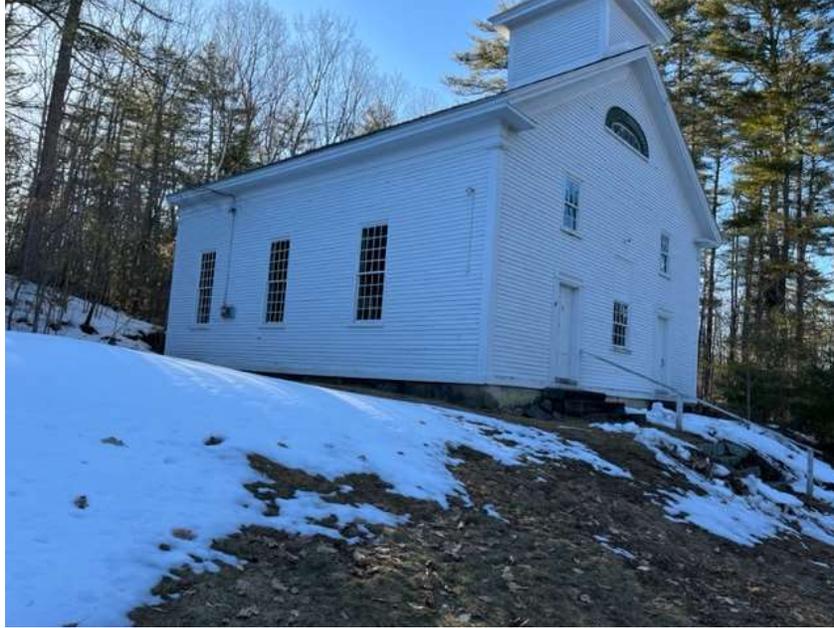
The town grange building currently is used for the storage of larger historical society memorabilia. Farm museum pieces and other items are stored and viewed in this space. The space is opened for public viewing on limited dates or by appointment only, perhaps only once or twice a year and only in the late spring, summer and early fall, as there is no heat available in this building. There are a few electrical outlets available as well as a few lights. There is not any water or bathroom facilities. It is not handicap accessible and parking is generally limited to the space by the old town hall, old fire station and perhaps the library. Discussion with historical society personnel indicated that there is some confusion as to where responsibility lies for issues which arise from the maintenance of this building. There is no regular or planned maintenance for this structure. The structure is generally sound but does need some cosmetic repair such as exterior trim and paint to insure it remains dry and protected from the elements. There is also a substantial rodent issue. Volunteers have spent considerable time cleaning and combating debris left behind by vermin. The building is generally not accessed by anyone in the winter. No interior or exterior signage is readily visible or available.

While there does not seem to be any additional need for this building at this time, it may be important to develop a maintenance plan to address repair or preventative maintenance issues. There is no known report of structural integrity or assessment for this building, which considering the age, may be worthwhile and valuable to accurately understand. Neglect of this building's maintenance could lead to costly results into the future. As a potential historic structure, this building may qualify for some grants for upgrades or repair, however, this remains in question as there would need to be some study and effort associated with the development of that opportunity.
