NORTH RIVER LAKE AREA

Emergency Lane Evaluation - Spring 2019

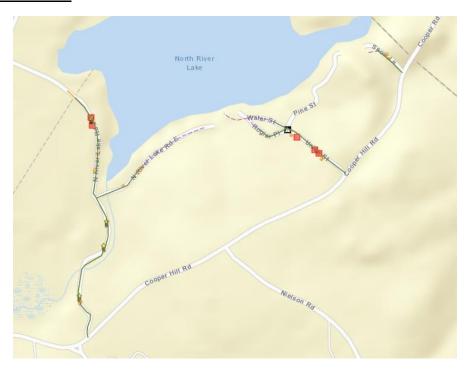
ELs appear in Green

Road Base: Very poor drainage between # 17 and # 31. Routinely standing water, no outlet.

Ledge/boulders protruding 500' in

Road Width: Sufficient for first 0.3 miles to N River Rd East intersection

Reduces to 14-16' in vicinity of #17-#20

Reduces further to <14' between rows of trees after #31

Sufficient after # 43

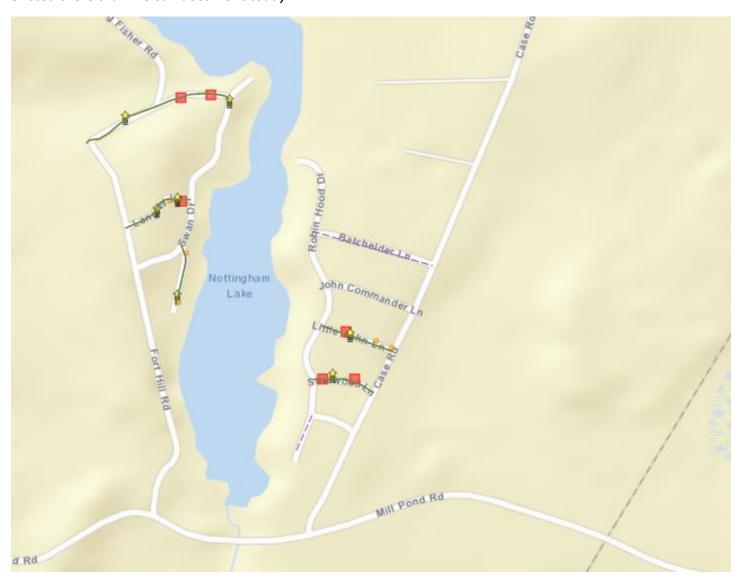
NOTTINGHAM LAKE AREA

ELs appear in Green

Robin Hood Dr – mostly paved, and has been treated as Class V road except for a short gravel stub at the South end.

Nottingham Ln – mislabeled on many maps as part of Robin Hood Ln, connects Case to Robin Hood. Paved, and acts as primary access to this neighborhood and has been treated as Class V.

Sherwood Ln and Little John Ln – parallel to Nottingham Ln connecting Case and Robin Hood, mislabeled on some maps, unpaved, and designated as ELs.

John Commander Ln – remnant exists but blocked by debris in the middle

Batchelder Ln - planned but not built, still appearing on maps.

Fort Hill Rd – the only access to this neighborhood, partially paved. Both paved an unpaved portions have been maintained. Assumed to end at the northern end of the development at the intersection of "Swan Dr."

Swan Dr – includes a portion formerly known as West Shore Dr. May now contain what on some maps is labeled as Harvey Dr or Marston Ln. "West Shore" and "Harvey" segments are paved, and gravel portion was not designated as EL. Gravel stub at South end has been plowed as EL.

Langley Ln – parallel cut-through from Fort Hill to Swan, unpaved, designated as EL.

Marston Ln – designated EL – which is it?

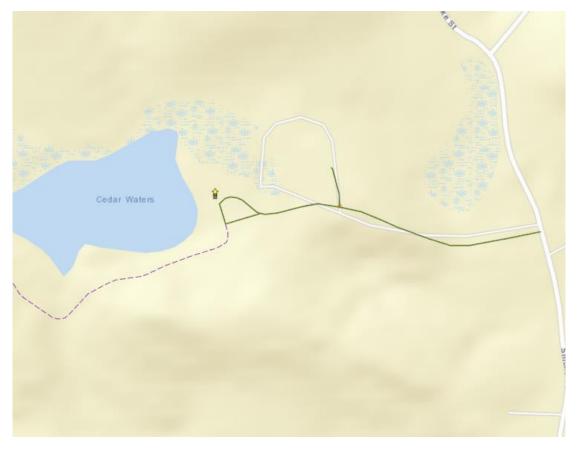
CEDAR WATERS VILLAGE

ELs appear in Green. NH-DOT map incorrect in this area.

<u>Designation:</u> "Main Rd" loop and one spur approx. 0.6 miles of access road and loop.

Road Base: One drainage problem location, otherwise sufficient

Road Width: Sufficient

Height: One obstacle back side of loop

Dead End/Turnaround: Stub requires long backout

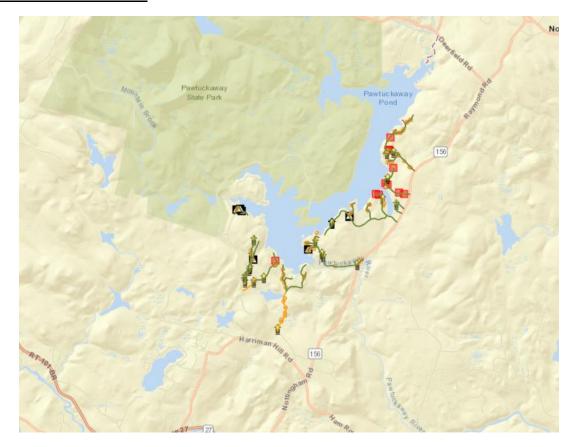
PAWTUCKAWAY LAKE AREA

ELs appear in Green, Yellow

<u>Designation:</u> Full length of main road, 1 mile; "First branch to intersection of driveway; second branch to top of hill; third branch;" 0.5 miles of branches.

Road Base: Generally sufficient, with occasional ledge/boulders, worst at distant end

Drainage/erosion trouble spot by culvert on entry straightaway, seems better since replacement

Road Width: <14' in three locations between second and third spurs

14'-16' on first and third spurs, and along back straightaway
