# 57\)

September 23, 2021 File No. 04.0191303.00

Re: Wetland Delineation Report Mooers Road, Tax Map 72, Lot 13-1 Nottingham, New Hampshire

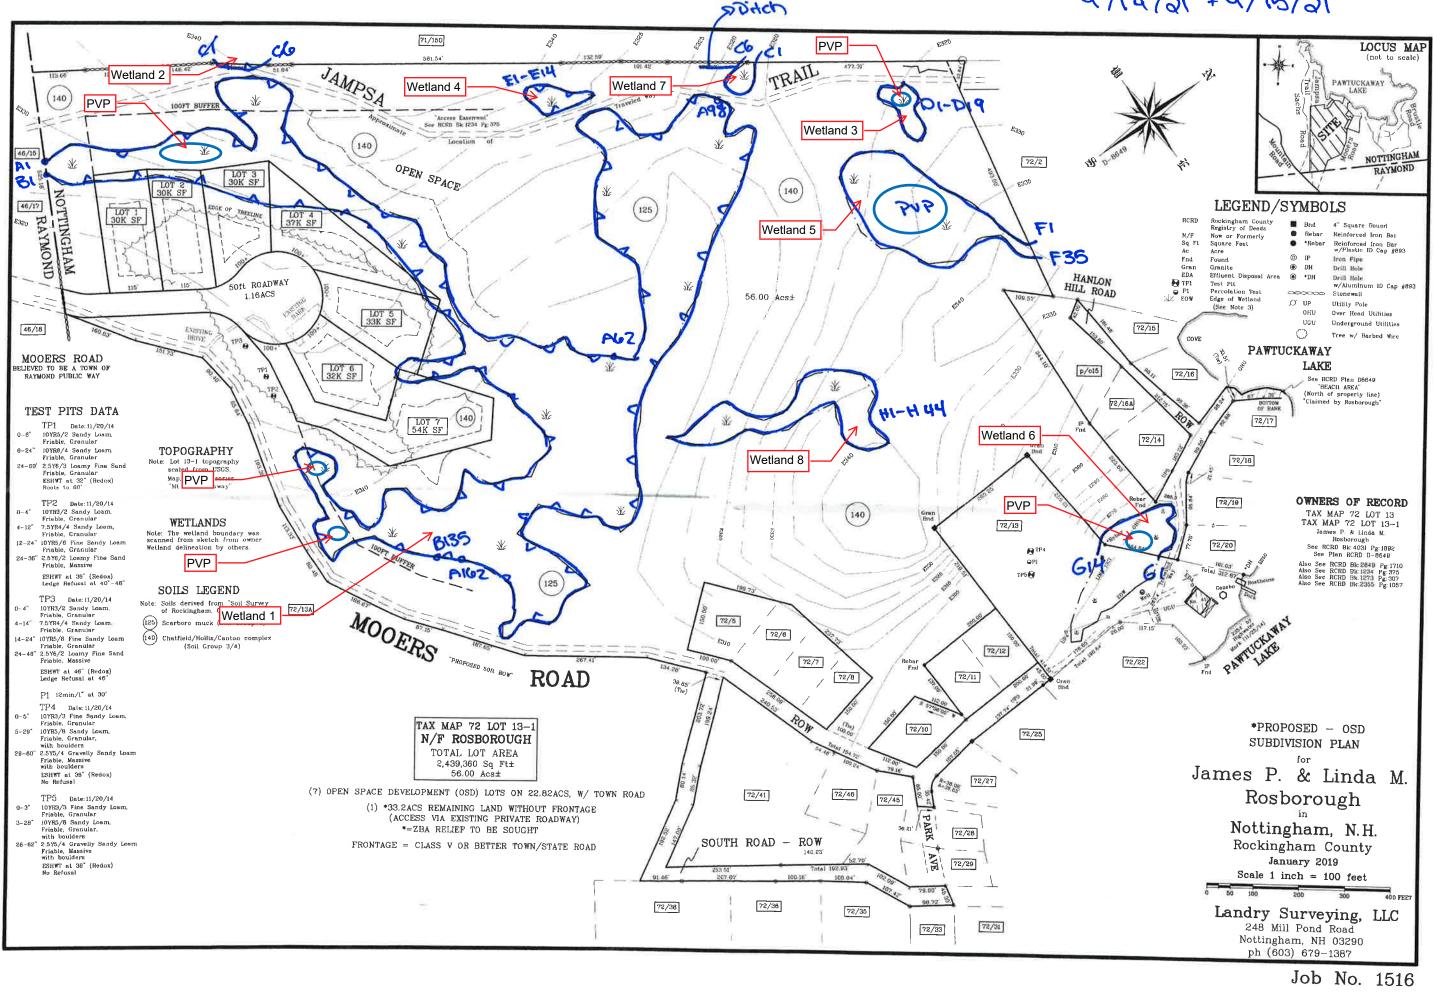
Figure 1 – Wetland Delineation Sketch

The Site contains eight palustrine emergent, scrub-shrub, and forested wetland systems (Wetlands 1-8 see **Table 1**, and **Figure 1 – Wetland Delineation Sketch)**.

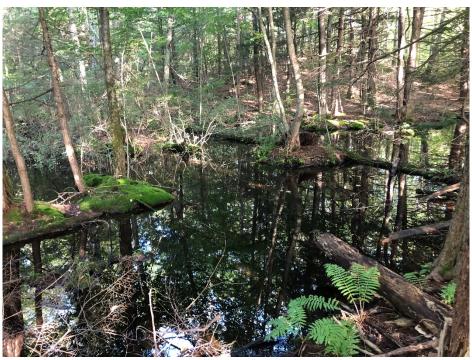
Photograph No. 1: Looking northwesterly into Wetland 1 from wetland flag B20.

Wetland 1 is located in the central and southernmost portions of the Site and is demarcated by the A-line and B-line wetland flags (see **Figure 1 – Wetland Delineation Sketch**). Wetland 1 is classified as a palustrine emergent and forested wetland system dominated by broad leaved deciduous and evergreen vegetation that is seasonally and permanently flooded/saturated (PEM1Fg,PFO1,4E,PFO1/4Fg). The ponded portion of Wetland 1 is classified as a palustrine emergent wetland system with unconsolidated bottom that is permanently flooded/saturated with beaver activity (PUBHb/PEM1Fgb). Wetland 1 contains an unnamed intermittent stream that is classified as an intermittent riverine system with unconsolidated bottom (R4UB) Dominant vegetation in the wetland includes cinnamon fern (*Osmundastrum cinnamomeum*), sensitive fern (*Onoclea sensibilis*), royal fern (*Osmunda regalis*), fringed sedge (*Carex crinita*), sphagnum moss (*Sphagnum spp.*), American bur-reed (*Sparganium Americanum*), goldthread (*Coptis trifolia*), highbush blueberry (*Vaccinium corymbosum*), meadowsweet (*Spiraea alba*), maleberry (*Lyonia ligustrina*), common winterberry (*Ilex verticillate*), American witch-hazel (*Hamamelis virginiana*), red maple (*Acer rubrum*), yellow birch (*Betula alleghaniensis*), black gum (*Nyssa sylvatica*), eastern hemlock (*Tsuga canadensis*), and white pine (*Pinus strobus*). The soils in the exterior portion of the wetland are classified as hydric soil with a depleted matrix below a dark surface (hydric soil indicator A11). The soils on the interior of the wetland are classified as hydric soil indicator A1).

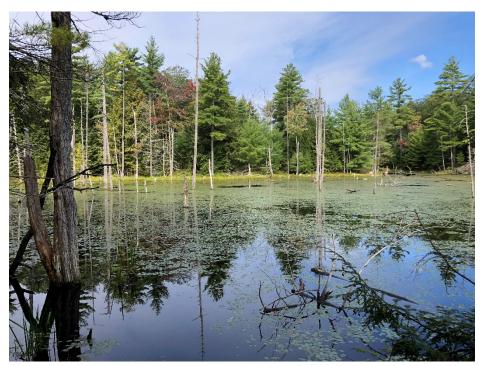
Photograph No. 2: Looking northerly into the ponded portion of Wetland 1.

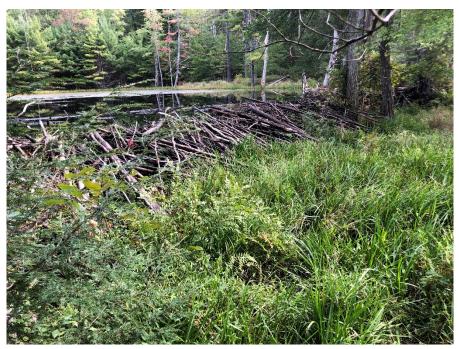
Photograph No. 3: Looking northerly at an existing beaver dam within Wetland 1 near wetland flag B64.

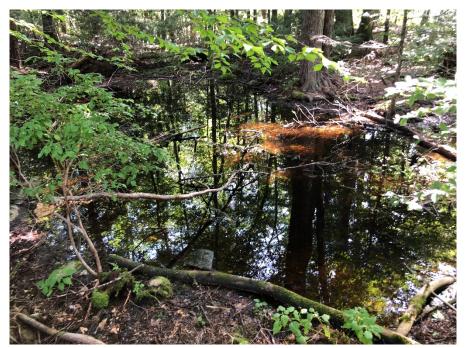
Photograph No. 4: Looking easterly into a potential vernal pool within Wetland 1 near wetland flag B99.

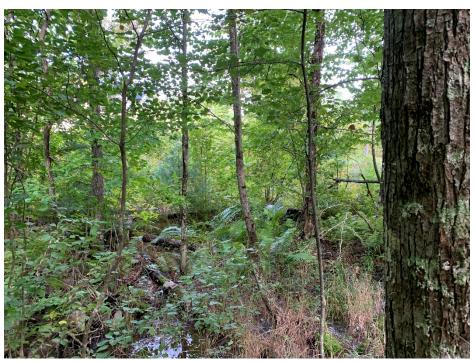
Photograph No. 5: Looking westerly into Wetland 2 from Jampsa Trail.

Wetland 2 is located in the southwestern portion of the Site and is demarcated by the C-line wetland flags (see **Figure 1** – **Wetland Delineation Sketch**). Wetland 2 is classified as a palustrine forested wetland system dominated by broad leaved deciduous and evergreen vegetation that seasonally flooded/saturated (PFO1/4E). Dominant vegetation in the wetland includes cinnamon fern, sensitive fern, sphagnum moss, highbush blueberry, maleberry, common winterberry, red maple, yellow birch, eastern hemlock, and white pine. The soils in the wetland are classified as hydric soils with a depleted matrix below a dark surface (hydric soil indicator A11).

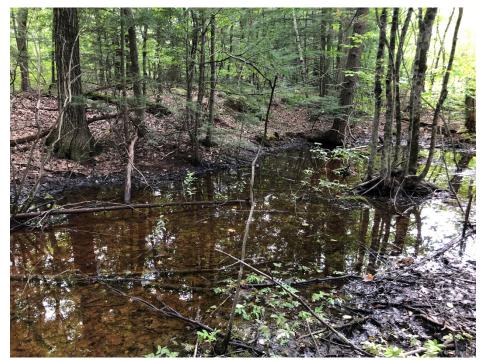
Photograph No. 6: Looking southerly into a potential vernal pool within Wetland 3 near wetland flag D6.

Wetland 3 is located in the northernmost portion of the Site and is demarcated by the D-line wetland flags (see **Figure 1** – **Wetland Delineation Sketch**). Wetland 3 is classified as a palustrine forested wetland system dominated by broad leaved deciduous and evergreen vegetation that seasonally flooded/saturated (PFO1/4E). Dominant vegetation in the wetland includes cinnamon fern, sensitive fern, highbush blueberry, common winterberry, red maple, yellow birch, eastern hemlock, and white pine. The soils in the exterior portion of the wetland are classified as hydric soils with a depleted matrix below a dark surface (hydric soil indicator A11). The soils within the interior of the wetland are classified as hydric soils that have organic soil material at or near the soil surface that are greater than 8 inches and less than 16 inches thick (hydric soil indicator A2).

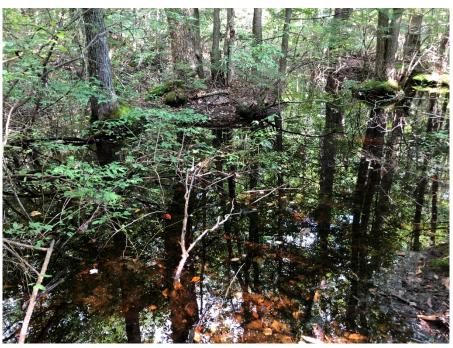
Photograph No. 7: Looking easterly into the Wetland 5 near wetland flag F6.

Wetland 5 is located in the northernmost portion of the Site and is demarcated by the F-line wetland flags (see **Figure 1** – **Wetland Delineation Sketch**). Wetland 5 is classified as a palustrine forested wetland system dominated by broad leaved deciduous and evergreen vegetation that permanently flooded/saturated (PFO/4E, PFO1/4Fg). Dominant vegetation in the wetland includes cinnamon fern, sensitive fern, highbush blueberry, common winterberry, red maple, yellow birch, eastern hemlock, and white pine. The soils in the exterior portion of the wetland are classified as hydric soils with a depleted matrix below a dark surface (hydric soil indicator A11). The soils on the interior of the wetland are classified as hydric soils that have organic soil material at or near the soil surface that are greater than 16 inches thick (hydric soil indicator A1).

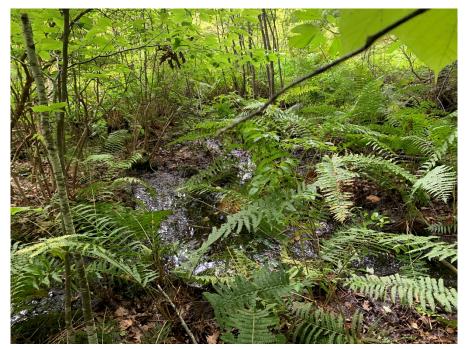
Photograph No. 8: Looking southeasterly into Wetland 6 near wetland flag G14.

Wetland 6 is located in the northeastern portion of the Site and contains the G-line wetland flags 1-14 (see **Figure 1** – **Wetland Delineation Sketch**). Wetland 6 is classified as a palustrine emergent and scrub-shrub wetland system dominated by broad leaved deciduous vegetation that permanently flooded/saturated (PFO1/4E, PFO1/4Fg). Dominant vegetation in the wetland includes cinnamon fern, sensitive fern, marsh fern (*Thelypteris palustris*), sphagnum moss, highbush blueberry, common winterberry, red maple, yellow birch, eastern hemlock, and white pine. The soils in the exterior portion of the wetland are classified as hydric soils with a depleted matrix below a dark surface (hydric soil indicator A11). The soils on the interior of the wetland are classified as hydric soil indicator A1).

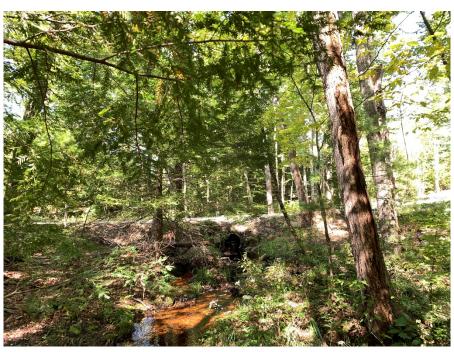
Photograph No. 9: Looking easterly into the Wetland 7 and existing culvert at Jampsa Trail.

wetland includes cinnamon fern, meadowsweet, highbush blueberry, red maple, yellow birch, and eastern hemlock. The soils in the wetland are classified as hydric soils with a depleted matrix below a dark surface (hydric soil indicator A11). Wetland 7 connects to Wetland 1 through an existing culvert under Jampsa Trail.

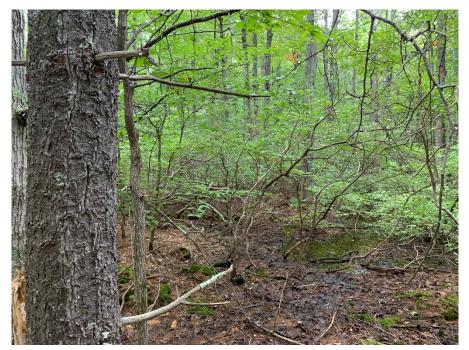
Photograph No. 10: Looking into Wetland 8 near wetland flag H37.

Wetland 8 is located in the central portion of the Site and contains the H-line wetland flags (see **Figure 1 – Wetland Delineation Sketch**). Wetland 8 is classified as a palustrine forested wetland system dominated by broad leaved deciduous and evergreen vegetation that seasonally flooded/saturated (PFO1/4E). Dominant vegetation in the wetland includes cinnamon fern, sensitive fern, gold thread, sphagnum moss, highbush blueberry, common winterberry, red maple, yellow birch, eastern hemlock, and white pine. The soils in the wetland are classified as hydric soils with a depleted matrix below a dark surface (hydric soil indicator A11).
